NPDES Compliance Inspection Report

DEPARTMENT OF ECOLOGY
NORTHWEST REGIONAL OFFICE
INSPECTION REPORT

FACILITY: Treoil Industries, Ltd.

TYPE OF FACILITY: Distillation of tall oil

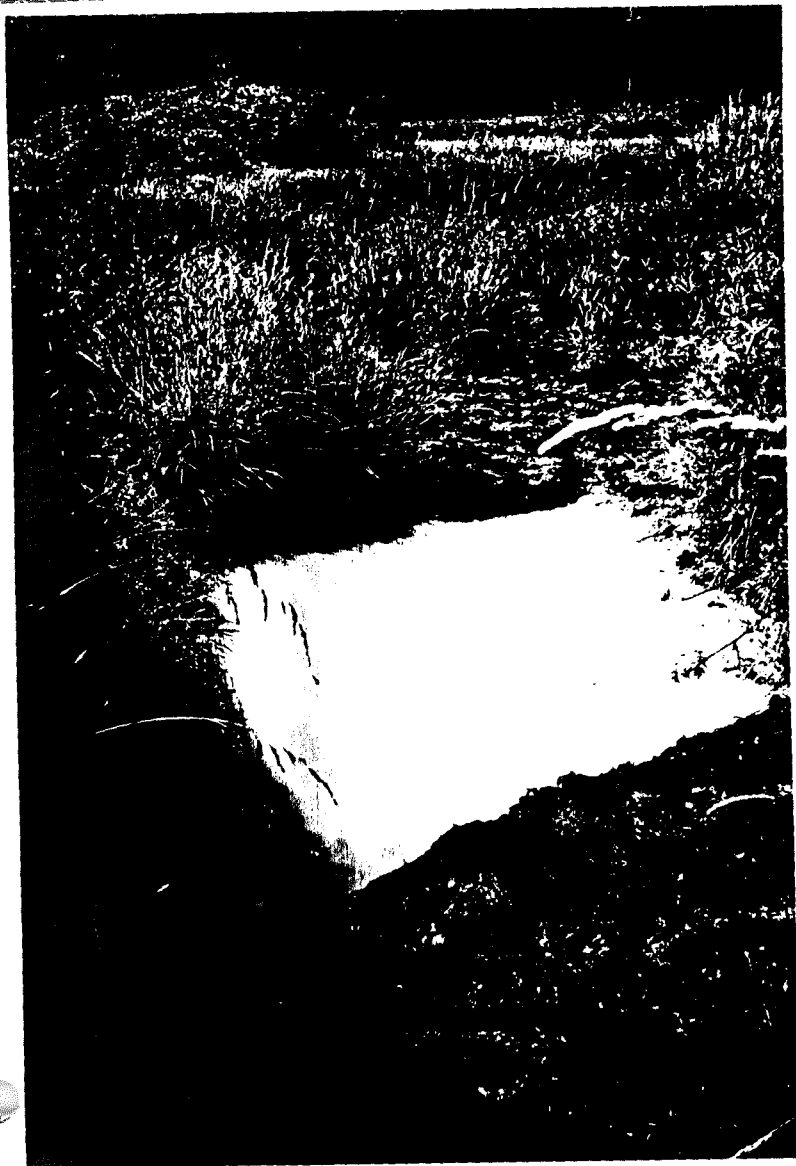
PHOTO No: 1 DATE: 8/13/92 TIME: 11:20
 TAKEN BY: Pam Elardo WITNESS: Doug Knutson
 FILM/SPEED: _____ CAMERA: _____
 DESCRIPTION: South Swamp outside
Trefoil Property
 COMMENTS: Water very turbid
Some soil contamination visible

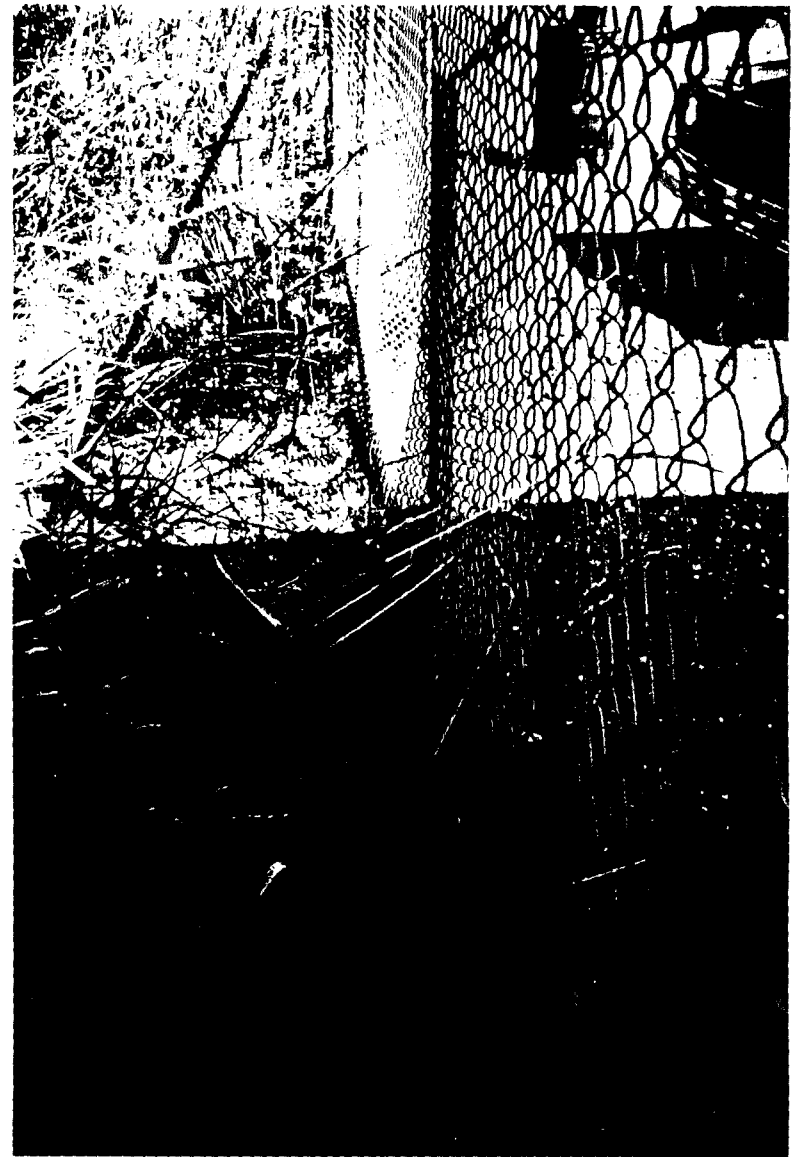
PHOTO No: 2 DATE: 8/13/92 TIME: _____
 TAKEN BY: PE WITNESS: DK
 FILM/SPEED: _____ CAMERA: _____
 DESCRIPTION: Trench leading to South Swamp
 COMMENTS: oil contamination visible

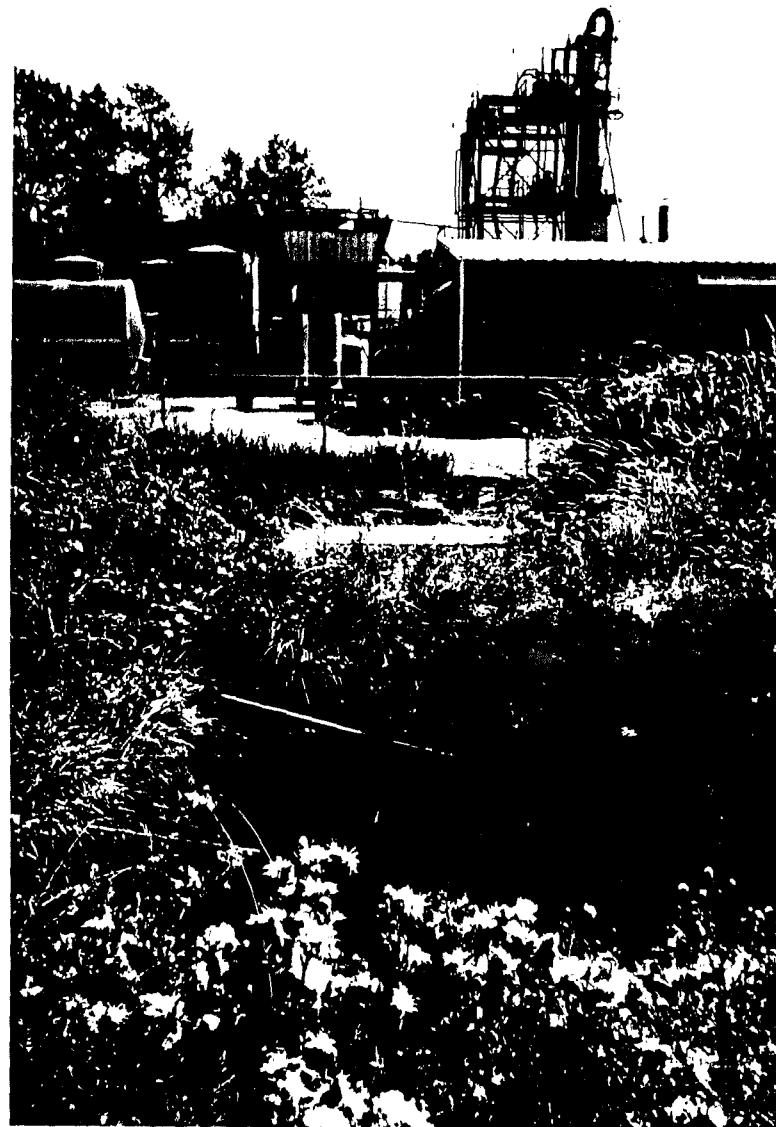
PHOTO No: 4 DATE: 8/13/92 TIME: _____
 TAKEN BY: PE WITNESS: DK
 FILM/SPEED: _____ CAMERA: _____
 DESCRIPTION: second chamber of North Sump
 COMMENTS: Thick, turbid, black

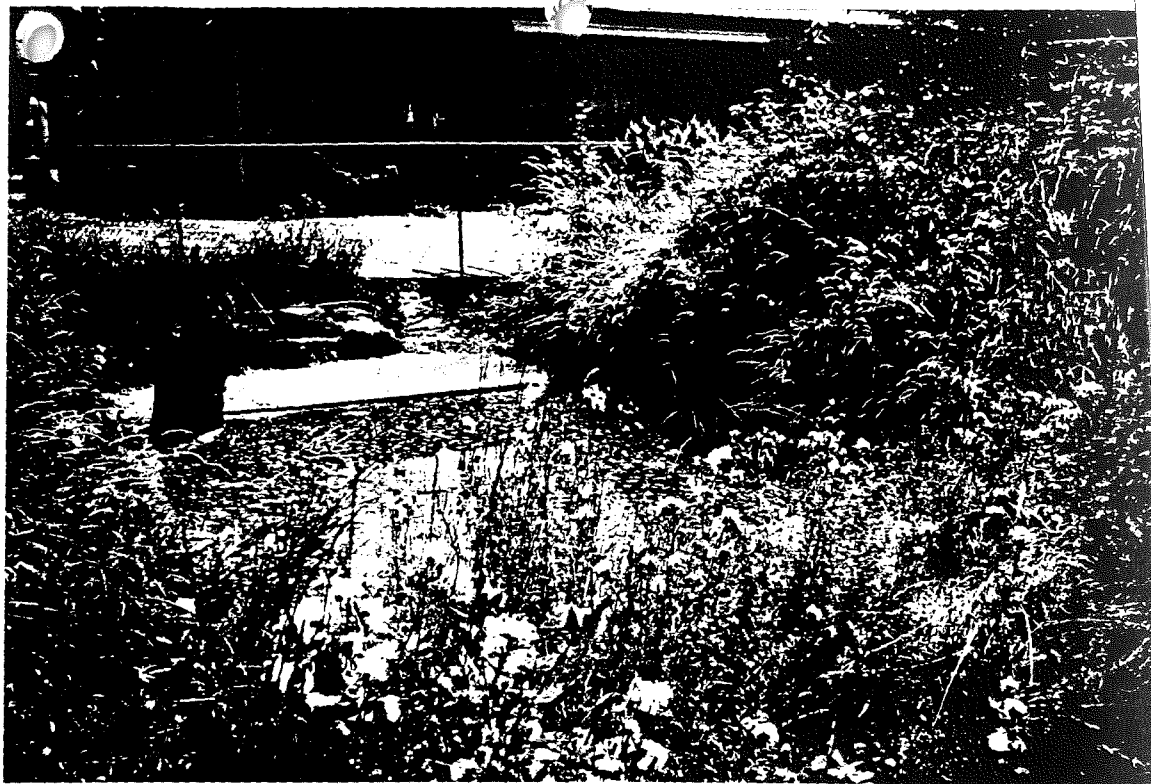
PHOTO No: 5
DATE: 8/13/92
TIME: 11:50
TAKEN BY: PC
WITNESS: DK
FILM/SPEED:
CAMERA:

First chamber
of Water
Sump

highly
contaminated

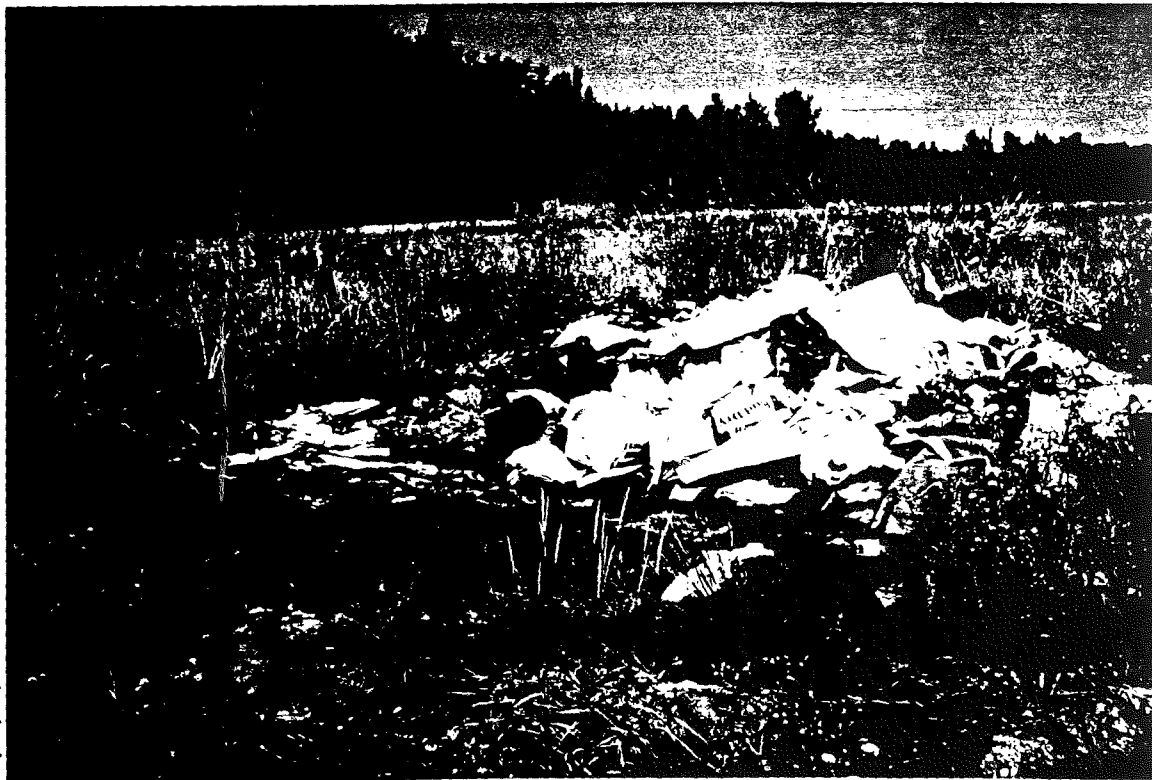
PHOTO No: 6
DATE: 8/13/92
TIME:
TAKEN BY: PC
WITNESS: DK
FILM/SPEED:
CAMERA:

5. Solid waste piles were haphazardly scattered about outside and inside the fenced property. An oily sludge was visible next to an empty drum.

solid waste
outside
fence

- I will try to contact Mr. Sidhu to determine what the plans are for the facility.
- I will contact solid waste inspector Stuart Kent and the Whatcom County Health Department to report the improper disposal of solid waste.
- I will also contact Norm Peck in the Clean Up program as this facility may be considered a contaminated site.

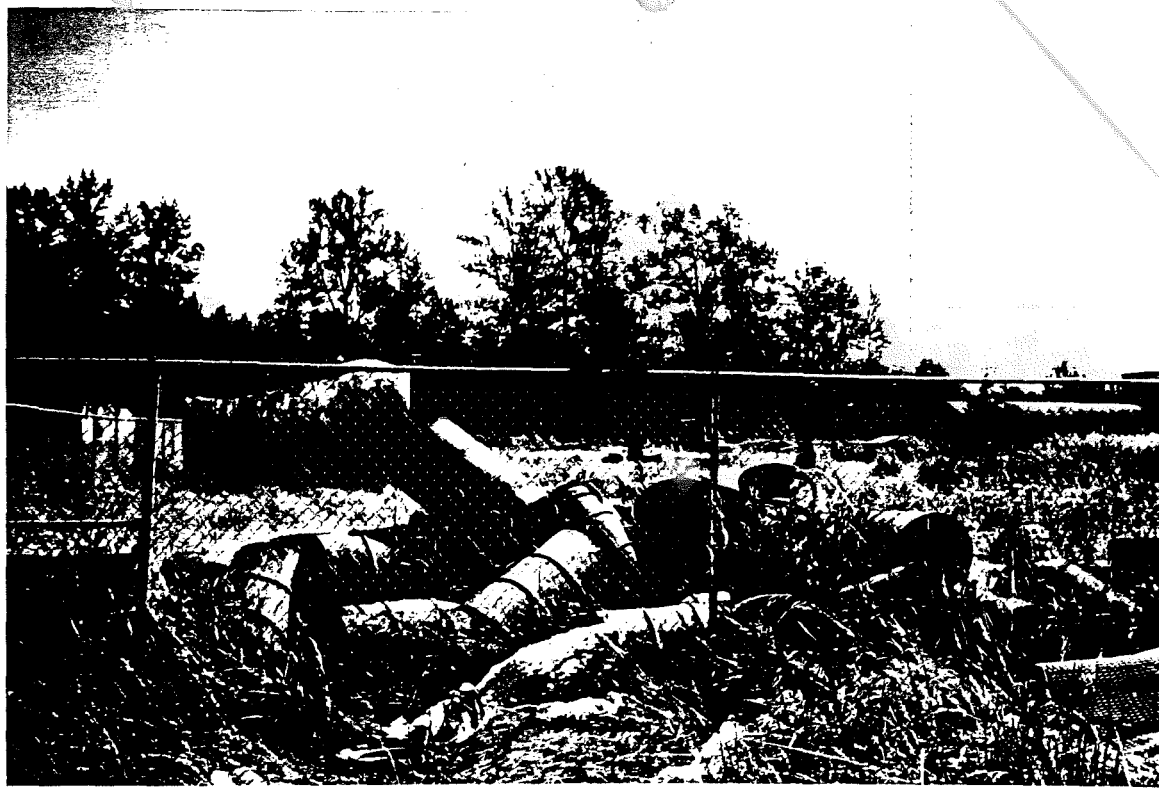
DATE: 8/13/92
TIME: 11:55
TAKEN BY: PE

stray drums
inside fenced
property

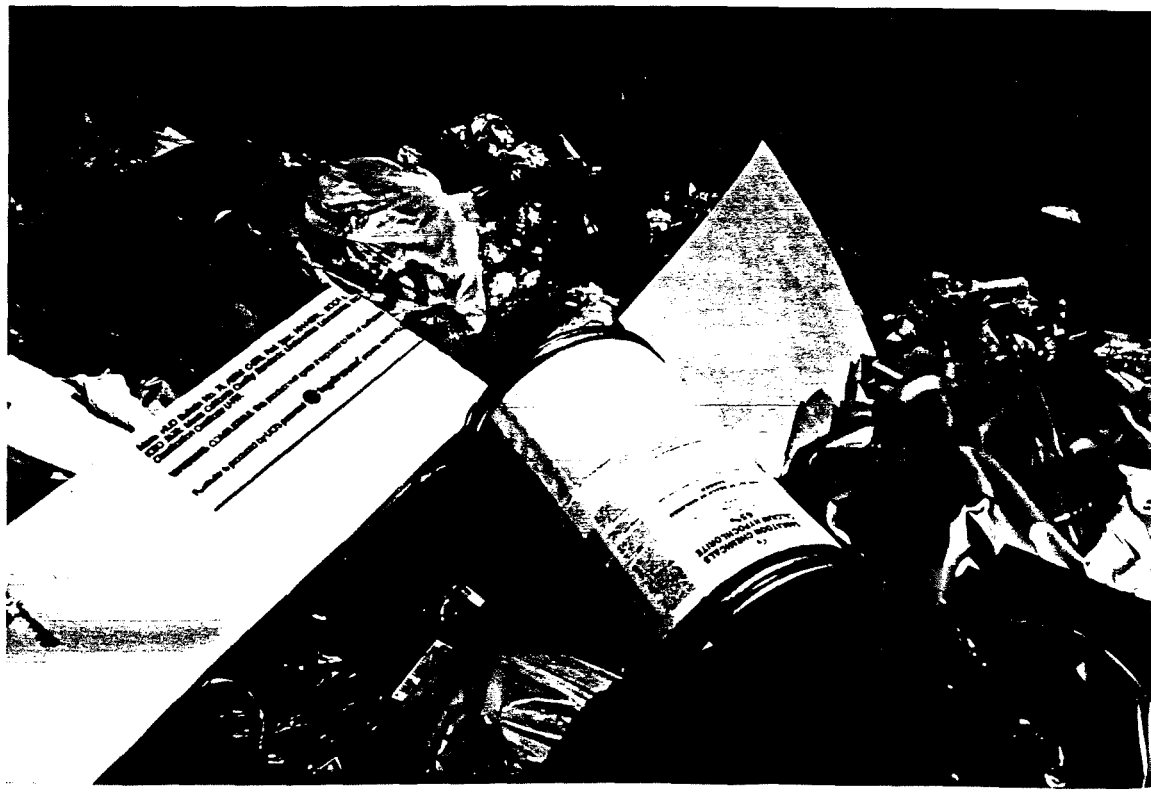
PHOTO No: 8
DATE: 8/13/92
TIME: _____
TAKEN BY: PE

solid waste
outside fence

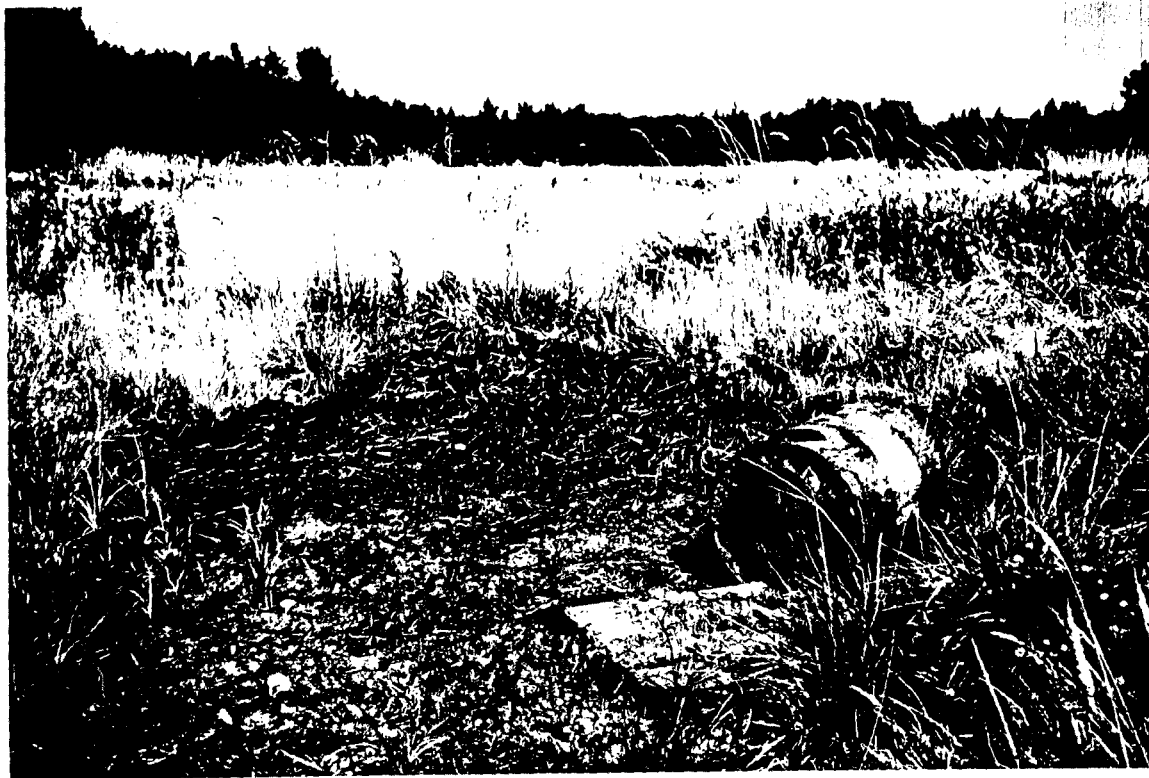
PHOTO No: 9 DATE: 8/13/92 TIME: 12
 TAKEN BY: PE WITNESS: DK
 FILM/SPEED: _____ CAMERA: _____
 DESCRIPTION: solid waste + soil contamination
near North Sump
 COMMENTS: _____

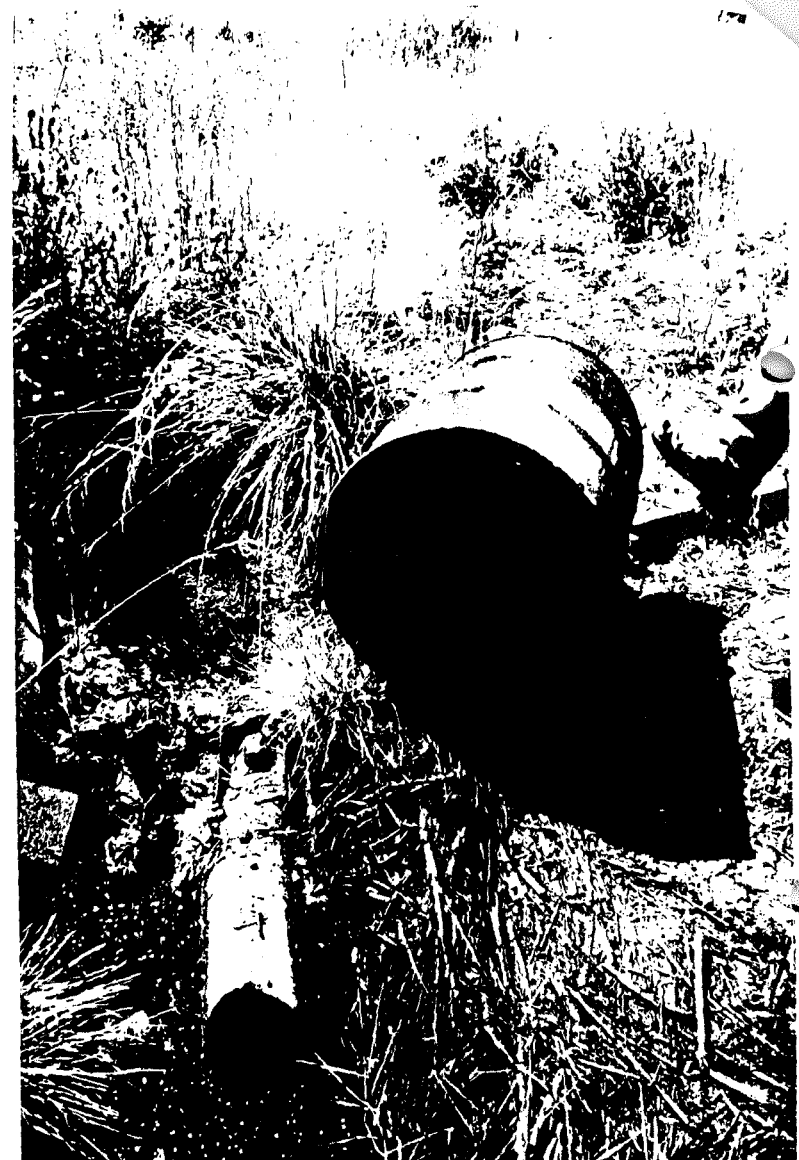
PHOTO No: 10 DATE: 8/13/92 TIME: _____
 TAKEN BY: PE WITNESS: DK
 FILM/SPEED: _____ CAMERA: _____
 DESCRIPTION: contaminated water + soil
near North Sump
 COMMENTS: _____

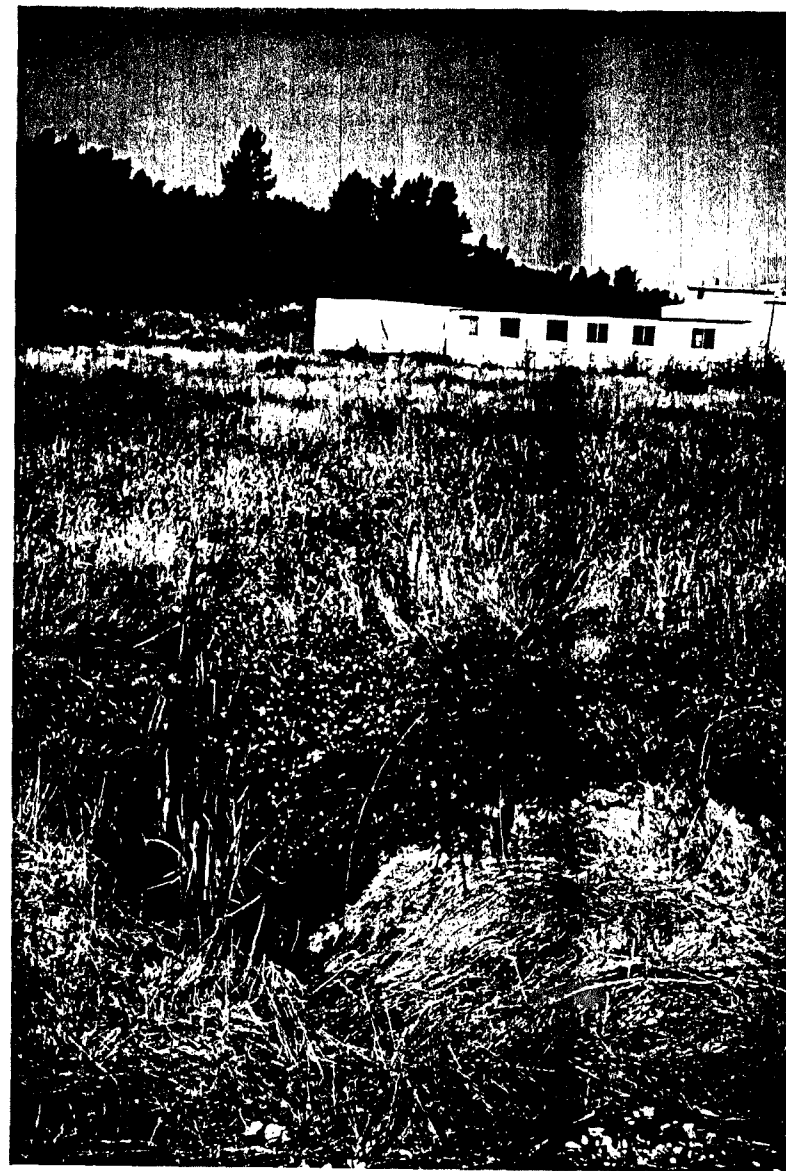
PHOTO No: 12 DATE: _____ TIME: _____
 TAKEN BY: _____ WITNESS: _____
 FILM/SPEED: _____ CAMERA: _____
 DESCRIPTION: Discharge from property
 COMMENTS: enters drainage ditch along
the road
